20 MILLION GALLON CONCRETE WATER TANK LINED WITH ELASTOMERIC POLYUREA

Customer: Florence Metropolitan Utility District

Engineers: HDR, Inc. Omaha NE

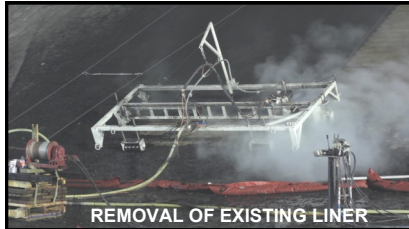
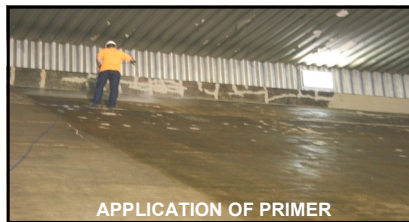
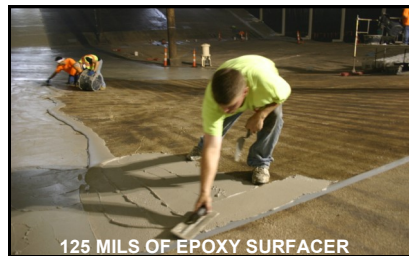
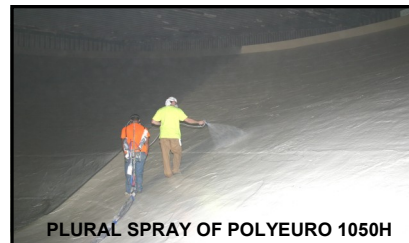
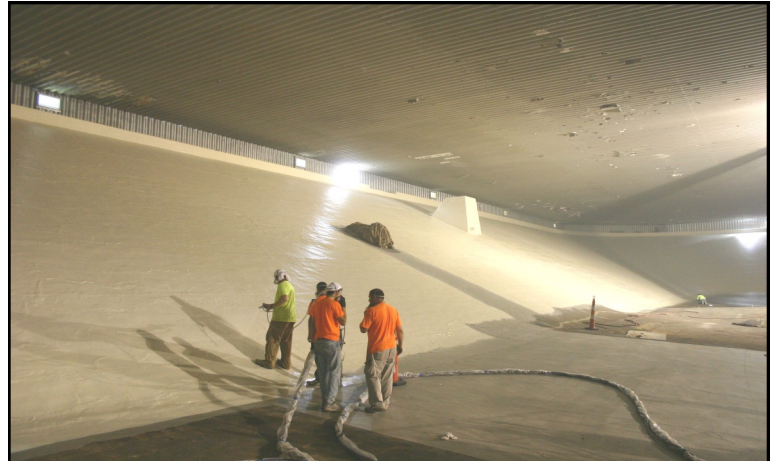
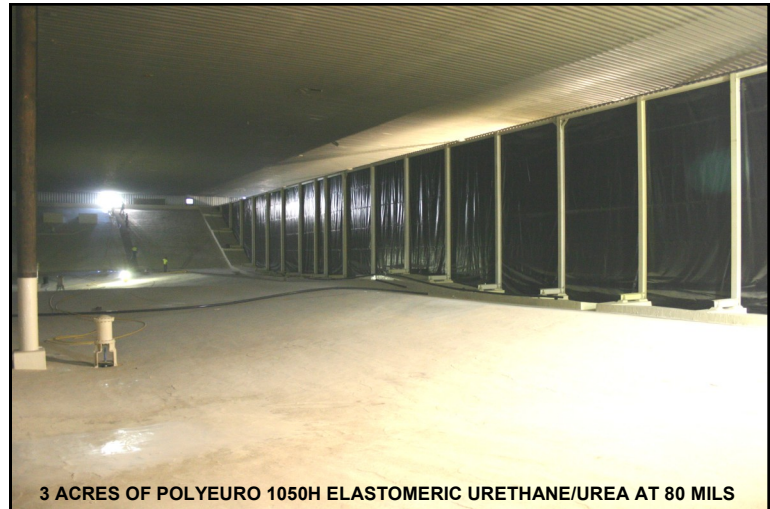
Material: Polycoat Products 1050 H, Fast Cure, 100% solids, Plural Spray Polyurethane/urea, Meeting NSF Standards.

Specs: 100 year old Concrete Deck, 125 Mils Polycoat Epoxy Filler #21, Primer #21, 80 mils Polyeuro 1050 H

Details: *100 year old Saturated concrete would not dry out to meet Industry standards for lining. It was not practical or affordable to use DH equipment, so McGill had to test double priming the surface using the PolyPrime #21 prior to the Epoxy Grout.

*Applying the Polycoat Grout at 125 mils on sloped surfaces had never been done before at those thicknesses. It was an easy fix using additional "filler #21" to stiffen the build of the grout so it would remain in place.

*Water still seeping in from multiple underground cracks were injected with hydrophobic urethane and epoxy resins.

*Project was completed on time without any delays even with the concrete moisture and infiltration issues.
